Inspection Report

BUILDING NAME:	Fire Lookout
DATE OF INSPECTION:	07/24/2008
TIME OF INSPECTION:	4:30 pm
LONGITUDE:	W-124.02.385
LATITUDE:	N-42.41.617
ALTITUDE:	3636 feet above sea level
THE BUILDING FACES APROXIMATELY:	South

4215
Bald Knob Lookout
Powers Ranger District

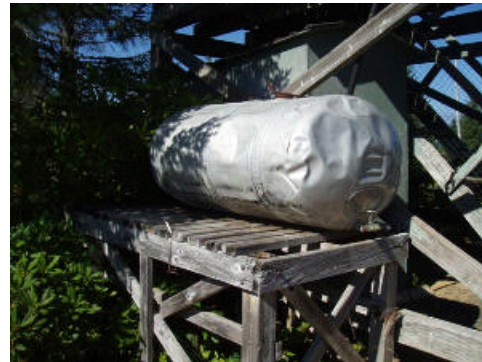
There is no water at this facility. There is a water tank but it was empty.
SEWAGE DISPOSAL:	There is an outhouse down the hill.
UTILITIES STATUS:	The only utility is propane. It was on.

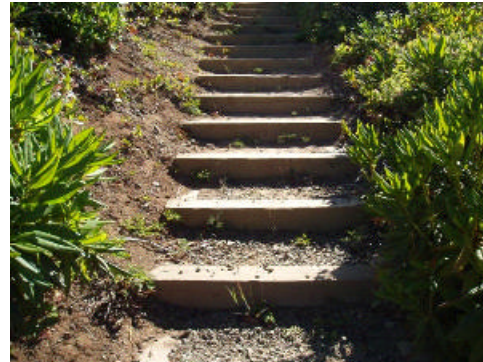
The stairway leading from the lot to the tower is in good condition and the railings are secure. There are some sections that have no railings. Consider installing railings at these locations.

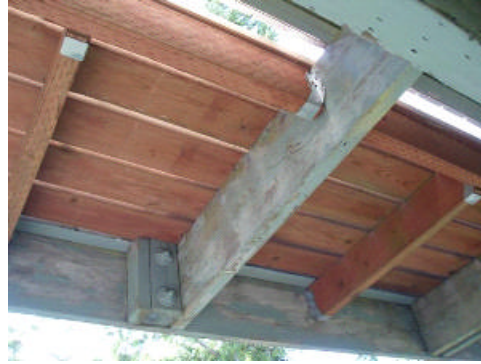
The overall condition of the deck is good. New pressure treated framing and redwood treads were noted.

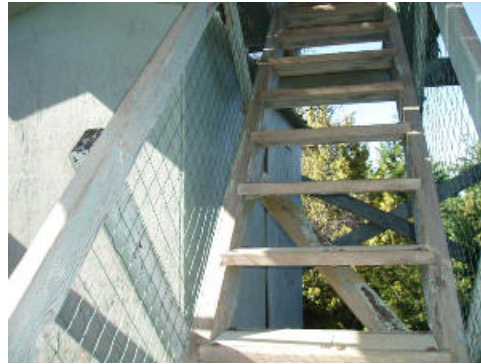
The stairway is wood framed with wood treads. Roofing shingles have been installed to provide traction. The overall condition is good. The roofing shingle material is beginning to wear and lose its effectiveness. Bare wood is noted.

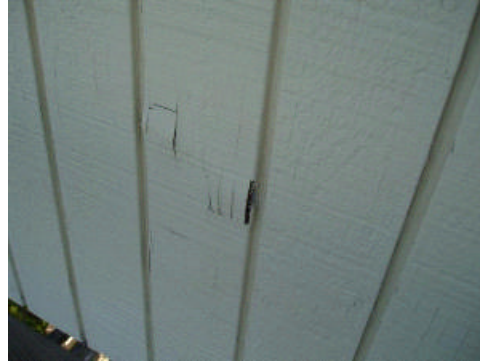
The siding is properly installed and is in good condition with no defects or unsealed penetrations. Minor delamination is noted at the front.

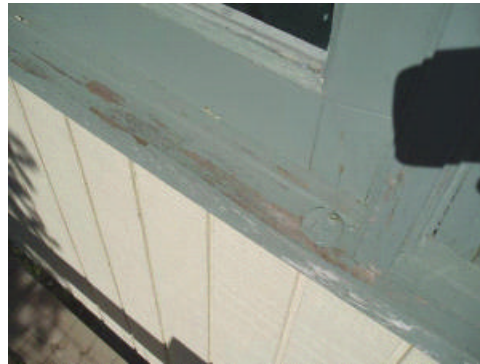
The trim is properly installed and in good condition. However, some areas are showing bare wood. All bare wood should be sealed with paint to protect it from the elements of nature.

2. The trim is properly installed and in good condition. However, some areas are showing bare wood. All bare wood should be sealed with paint to protect it from the elements of nature.

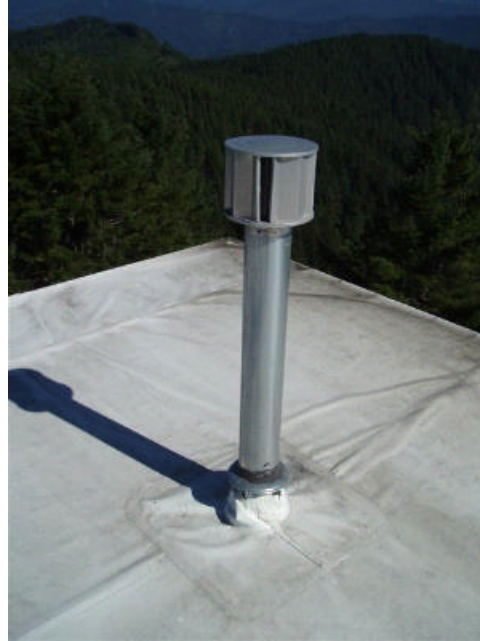
Metal - This is the exhaust for the propane heater.

The chimney is properly installed and in good condition.

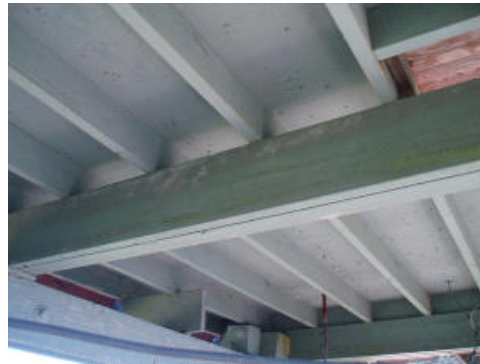
Tripled 2X10 mainly - In good condition

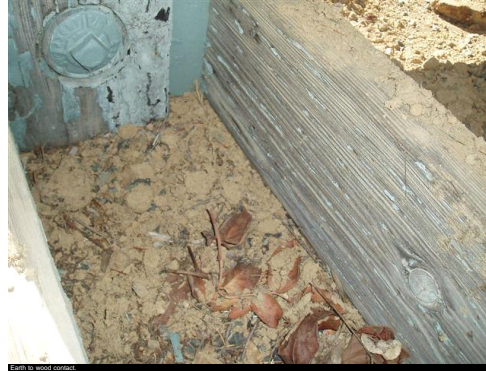
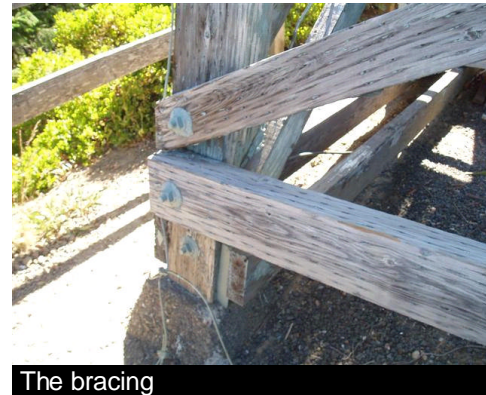
The bracing

8X8 lumber is used for the primary support with various sizes of dimensional lumber used for the bracing. Properly installed and in good condition. There is some earth to wood contact noted at lower bracing materials and the lower section of the stairs. I recommend the earth to wood contact be eliminated. The wood framing was painted at one time. Most of the paint is gone now. The wood is pressure treated but priming and painting the material will help to prolong its life.

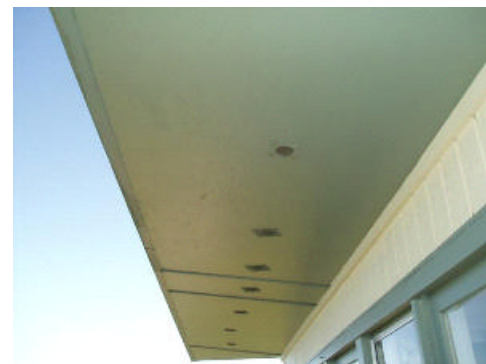
There is only a small attic area. It was not accessible. Soffit vents and one roof vent are installed.

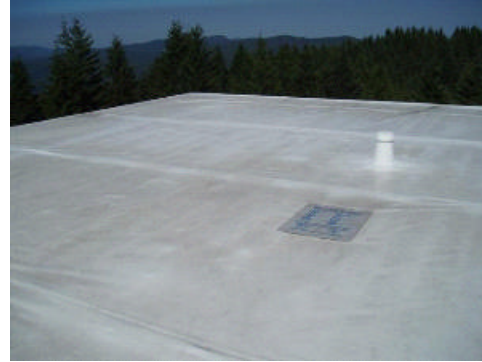
The roof covering is a single ply membrane. It is a Dura-last product.

The roofing material appears to be properly installed and in good condition.

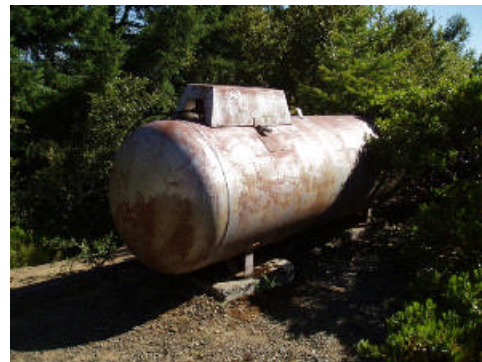
The propane tank is located at the left rear corner.

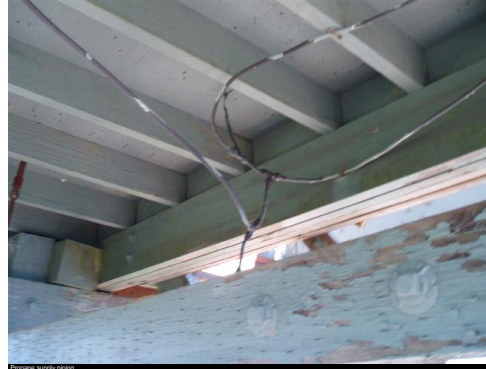
Flexible copper is the primary pipe used to distribute the propane. Current construction requirements include strapping copper and insulating it from rubbing against other materials. There are some 16d nails bent over some sections of pipe to secure them in place. These nails are not a qualified material for securing pipe. I recommend that a licensed plumber be brought in to further evaluate the propane distribution system and advise about how to make it safer. Taping insulation onto the pipe in any location where it may come in contact with other materials and anchoring it into place where possible may be viable solutions.

copper and insulating it from rubbing against other materials. There are some 16d nails bent over some sections of pipe to secure them in place. These nails are not a qualified material for securing pipe. I recommend that a licensed plumber be brought in to further evaluate the propane distribution system and advise about how to make it safer. Taping insulation onto the pipe in any location where it may come in contact with other materials and anchoring it into place where possible may be viable solutions.

3. Flexible copper is the primary pipe used to distribute the propane. Current construction requirements include strapping copper and insulating it from rubbing against other materials. There are some 16d nails bent over some sections of pipe to secure them in place. These nails are not a qualified material for securing pipe. I recommend that a licensed plumber be brought in to further evaluate the propane distribution system and advise about how to make it safer. Taping insulation onto the pipe in any location where it may come in contact with other materials and anchoring it into place where possible may be viable solutions.

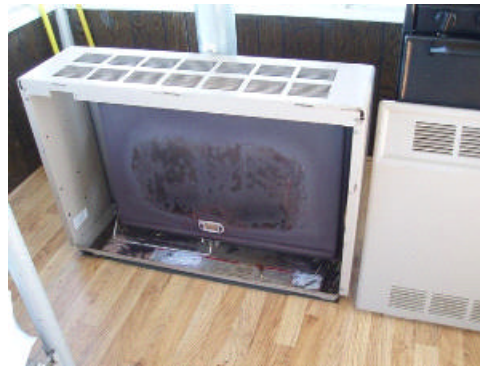
A space heater is installed.

The system worked once I was able to get the pilot lit. The pilot igniter sparked but never did light the pilot. I think it needs to be repositioned. The pilot lit with a match but I had to take the front cover off to get to it. I recommend adjusting the igniter so that the unit will operate the way it was designed to. After the pilot was lit the unit operated as intended.

I could not cipher the date code. The average life expectancy of a natural gas burning furnace is 18 years. This one is likely beyond that age. It appears to be functioning as intended. It should however be considered a deferred cost item. It could need service or replacement at any time.

4. The system worked once I was able to get the pilot lit. The pilot igniter sparked but never did light the pilot. I think it needs to be repositioned. The pilot lit with a match but I had to take the front cover off to get to it. I recommend adjusting the igniter so that the unit will operate the way it was designed to. After the pilot was lit the unit operated as intended.

1. I could not cipher the date code. The average life expectancy of a natural gas burning furnace is 18 years. This one is likely beyond that age. It appears to be functioning as intended. It should however be considered a deferred cost item. It could need service or replacement at any time.

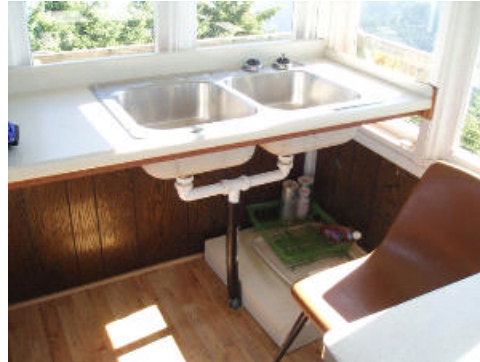
Stainless steel - The sink is in good condition with no dents or scratches.

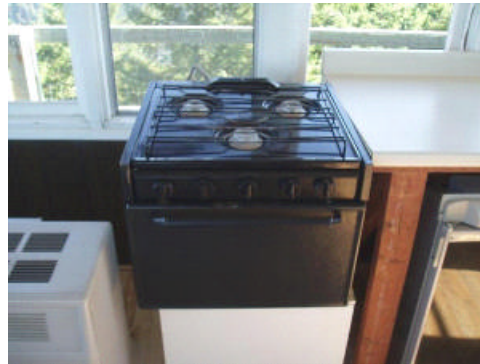
Propane burning - The burners were tested for operation and they all responded to the manual controls. The igniter did not light the system. Matches were needed. The oven was difficult to light. I recommend that the igniter be repaired or replaced.

5. Propane burning - The burners were tested for operation and they all responded to the manual controls. The igniter did not light the system. Matches were needed. The oven was difficult to light. I recommend that the igniter be repaired or replaced.

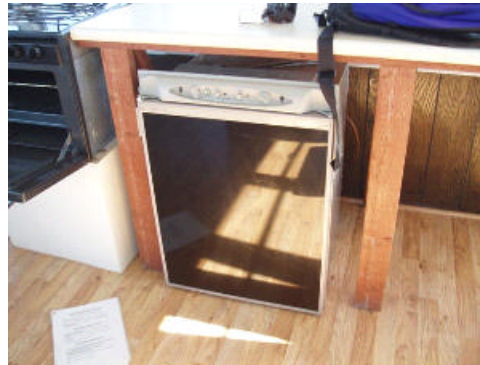
The propane refrigerator was functioning at the time of the inspection.

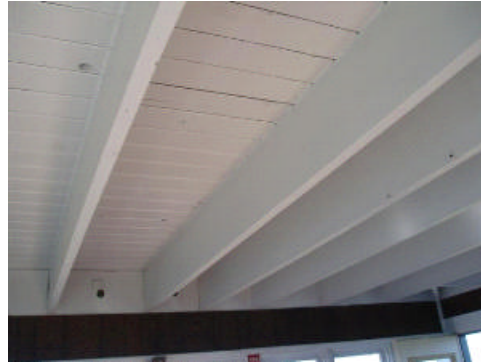
Exposed framing and 1 inch thick wood.

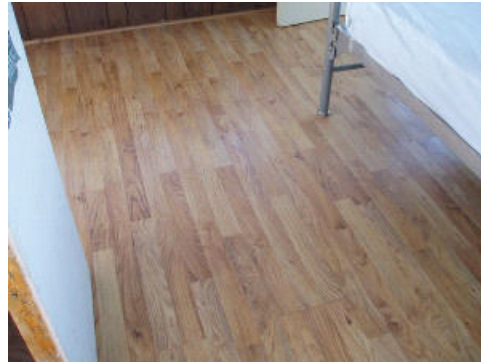
Laminate - The general condition is good.
