Inspection Report

Prepared by: Cornerstone Inspections
4678 Glen Echo Way
Central Point, OR 97502
541-664-1947

September 15, 2008
Prepared for:
Your Name
Property Inspected:
Your address
Grants Pass, OR 97527
Client's Realtor:
Your Realtor

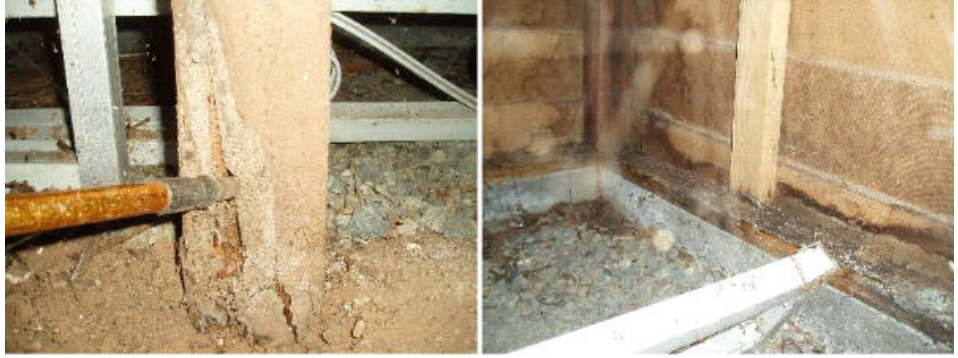
The overall condition is fair. There is some earth to wood contact and wood decay noted at some of the support post bases. The damage is not extensive. Water staining is noted at the mud sill and lower skirting also. I did not see any damage at these materials. I recommend that the earth to wood contact be eliminated and that any damaged material be repaired or replaced.

1. The overall condition is fair. There is some earth to wood contact and wood decay noted at some of the support post bases. The damage is not extensive. Water staining is noted at the mud sill and lower skirting also. I did not see any damage at these materials. I recommend that the earth to wood contact be eliminated and that any damaged material be repaired or replaced.

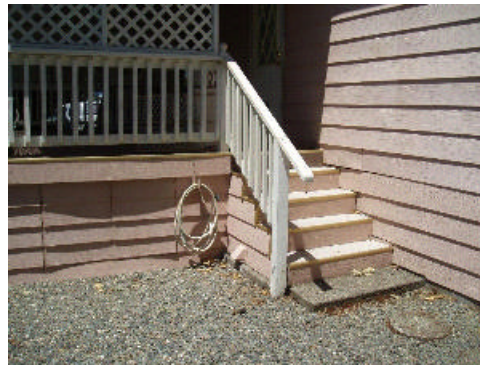
The railings are a bit loose at the stairs. I recommend that they be secured.

1. The railings are a bit loose at the stairs. I recommend that they be secured.

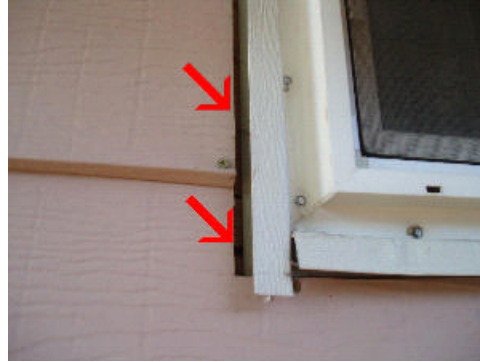
Some of the trim around the windows is not properly installed and has left gaps for water to enter. I recommend further evaluation by a licensed contractor and repairs as needed.

2. Some of the trim around the windows is not properly installed and has left gaps for water to enter. I recommend further evaluation by a licensed contractor and repairs as needed.

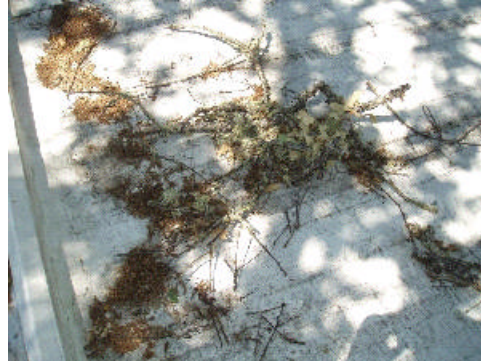
The roofing material appears to be properly installed and in good condition. The sealant should be inspected regularly and sealed as needed. Also, keep an eye out for dying branches that could damage the roof. There is debris on the roof. I recommend it be removed.

3. The roofing material appears to be properly installed and in good condition. The sealant should be inspected regularly and sealed as needed. Also, keep an eye out for dying branches that could damage the roof. There is debris on the roof. I recommend it be removed.

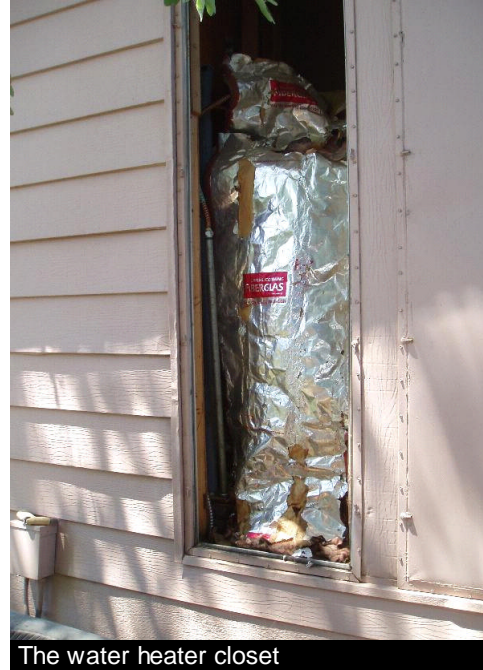
The water heater closet

APPROXIMATE AGE:	The unit is an electric model manufactured in 1994.
SIZE:	14 years - The average life expectancy of a water heater is 12 to 14 years. Depending on the quality of the component parts and the water quality it is not uncommon for them to last much longer. This one, although at the end of its statistical life appears to still be in good condition with no signs of leaking or rust. It should be monitored for leaking particularly around the base.
LOCATION:	50 Gallons
CONDITION:	The unit is located in an exterior closet at the rear of the structure.
INSTALLATION:	The unit is delivering hot water to the fixtures in the home.
CONDITION:	The water heater is properly installed and in compliance with all current safety requirements.
CONDITION:	New construction requires a drip pan that drains outside the structure. This is not a required upgrade but should be considered to help prevent any damage to the structure should the unit begin to leak.

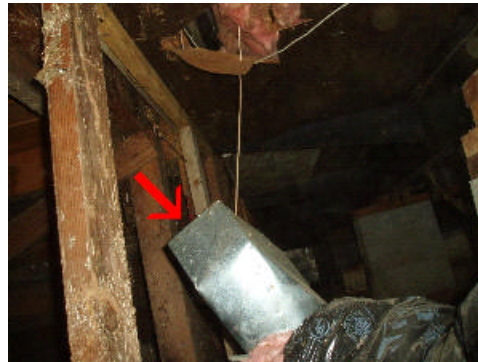
The overall condition is good. However, the duct near the kitchen is not connected and blowing into the crawl space. I recommend that this condition be corrected.

I recommend an HVAC technician be brought in to further evaluate, service, and repair the system in regards to: The condensation drain line, the disconnected duct near the kitchen, the dust build up on the A coil.

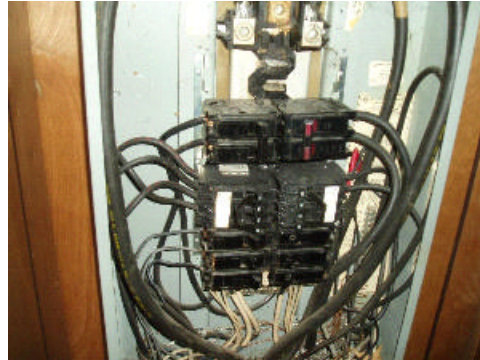
The main panel has been damaged. The damage was likely caused by water entering through the currently abandoned weather head. Water staining is noted on the ceiling above the panel. The overhead installation has been removed and the current electrical feed is from below. There is damage to the bus bars and they are labeled as such.

There are conditions in the electrical system which compel me to recommend it be further evaluated by a qualified electrical contractor. They are: The damaged bus bars in the main panel, reversed polarity to the left of the kitchen sink, mis-wired outlets in the left rear bedroom, and an open splice above the entrance to the storage shed.

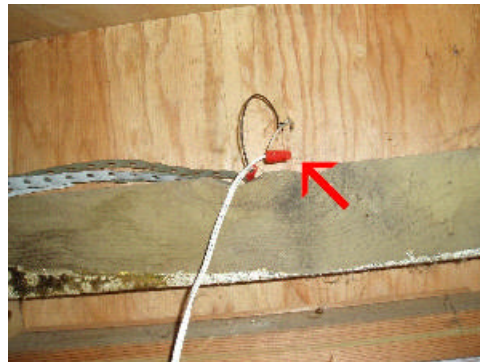
Splices are noted outside of a J-box at the left storage shed. I recommend that the splices be installed inside a j-box.

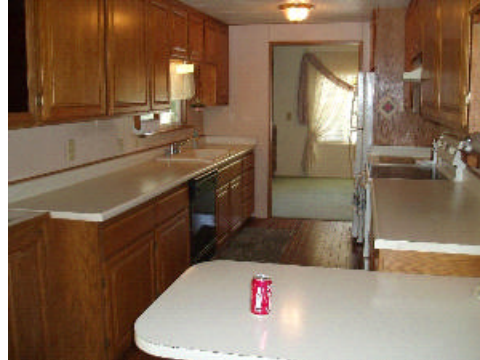
The doors and drawers were tested and were operational. One of the glass front cabinet doors has broken glass. Broken glass is a safety hazard and should be replaced.

3. The doors and drawers were tested and were operational. One of the glass front cabinet doors has broken glass. Broken glass is a safety hazard and should be replaced.

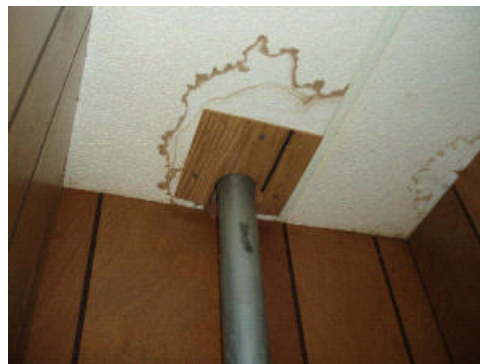
Manufactured panels typical of manufactured homes are found throughout. They are typically a drywall material with paper over them. Some damage and repairs are noted in

the ceiling over the dining room and family room. I do not know the cause of the damage. = Monitor for signs of moisture intrusion. Water staining is noted in the master bedroom closet. This area should also be monitored.

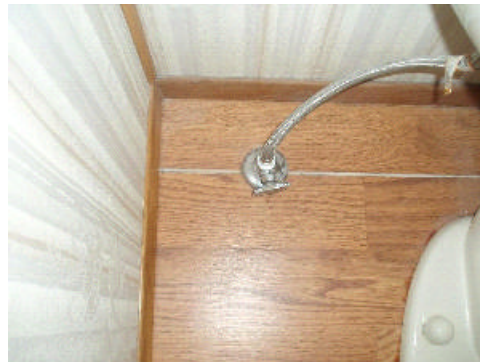
The laminate flooring appears to be in good condition. There is a gap behind the toilet in the master bathroom. This condition is cosmetic in nature and should be evaluated by the buyer.

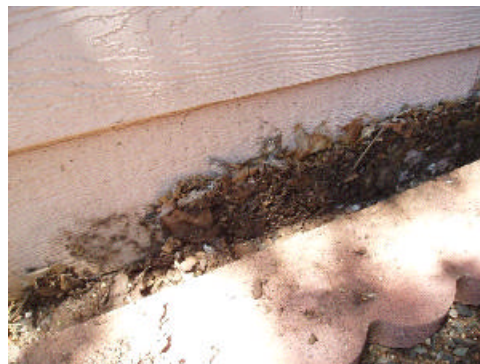
Metal & Wood - The overall condition is good. However, there is some earth to wood contact at the lower portion of wood skirting at the rear. Water staining in the material is noted. I recommend all earth to wood contact be eliminated.

9. Metal & Wood - The overall condition is good. However, there is some earth to wood contact at the lower portion of wood skirting at the rear. Water staining in the material is noted. I recommend all earth to wood contact be eliminated.
