## Inspection Report

**Prepared by: Cornerstone Inspections**  
4678 Glen Echo Way  
Central Point, OR 97502  
541-664-1947

## INSPECTION REPORT

TYPE OF BUILDING:	A commercial building, two stories high, site built using stick framing.
-------------------	--

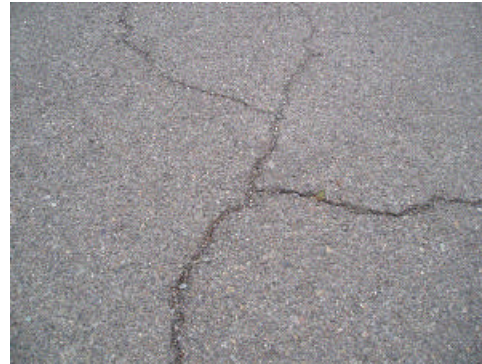
In good condition. Cracks are noted. Sealing the cracks to keep moisture out will slow down deterioration.

1. In good condition. Cracks are noted. Sealing the cracks to keep moisture out will slow down deterioration.

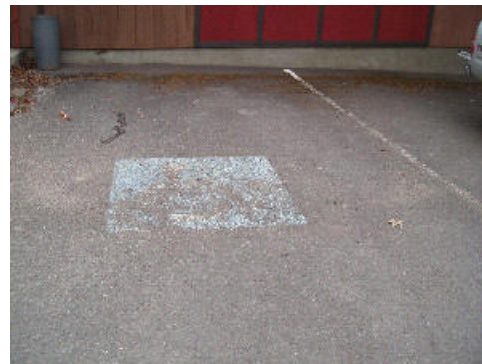
The paint is aged with fading and shipping noted.

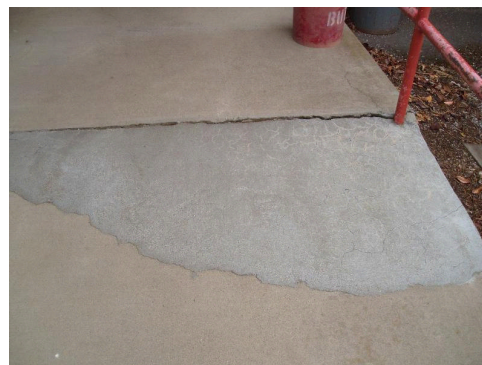
A patched section near the rear entrance

Concrete - In fair condition with patching noted. There are currently no tripping hazards or serious deterioration. There is a crack in the walkway to the right side door.

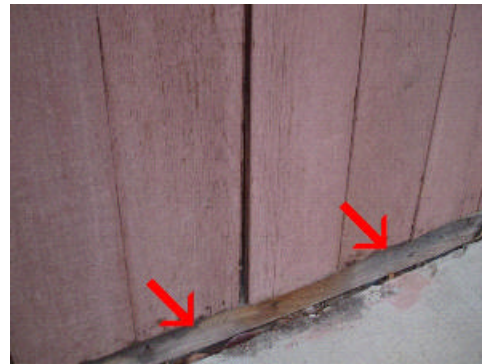
There is some exposed wood along the walkway near the rear door. I recommend that this area be flashed or sealed in a way which will prevent water from contacting the wood.

1. There is some exposed wood along the walkway near the rear door. I recommend that this area be flashed or sealed in a way which will prevent water from contacting the wood.

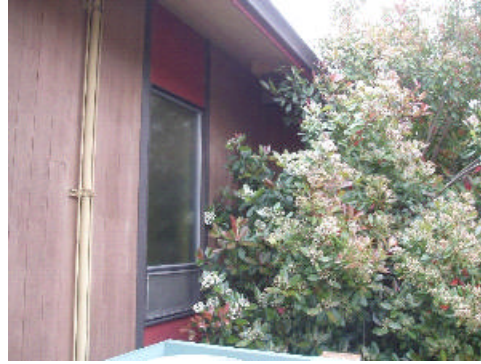
Maintenance is needed.

I recommend that the foliage be trimmed away from the structure. Plants and trees that are against the structure can wear away materials such as asphalt roof granules and paint. They also tend to slow the evaporation of moisture which can accelerate the breakdown of many materials.

2. I recommend that the foliage be trimmed away from the structure. Plants and trees that are against the structure can wear away materials such as asphalt roof granules and paint. They also tend to slow the evaporation of moisture which can accelerate the breakdown of many materials.

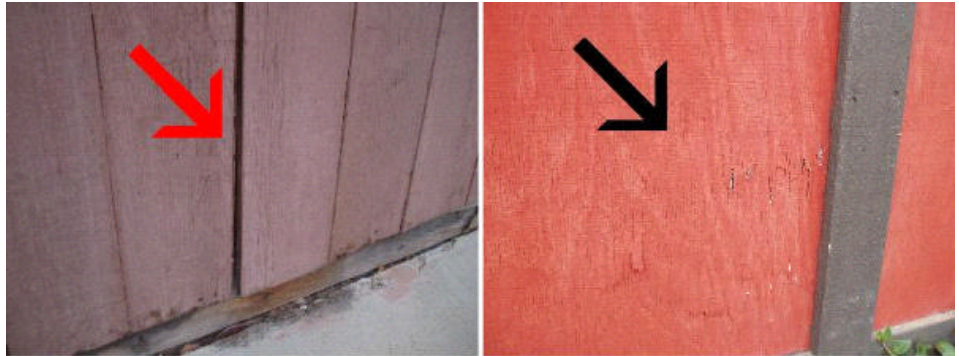
The overall condition is fair with some minor cupping and a couple of locations where gaps have opened up. Also, there is a little bit of delamination on the plywood. I recommend that all gaps where water could get by the siding be sealed. I recommend that delaminated areas receive a generous coat of paint. Only a few areas need this attention. There is an area at the right front corner where plants and debris have built up and are in contact with the trim and siding. I recommend that this area be cleared.

3. The overall condition is fair with some minor cupping and a couple of locations where gaps have opened up. Also, there is a little bit a delamination on the plywood. I recommend that all gaps where water could get by the siding be sealed. I recommend that delaminated areas receive a generous coat of paint. Only a few areas need this attention. There is an area at the right front corner where plants and debris have built up and are in contact with the trim and siding. I recommend that this area be cleared.

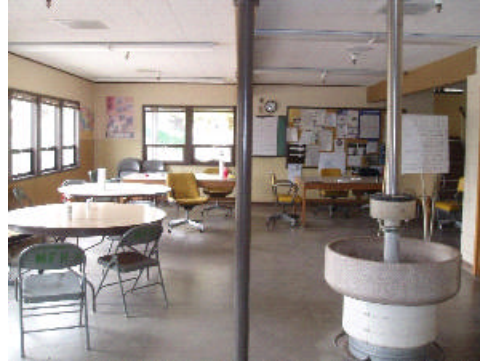
Good with some cracking noted but no displacement.

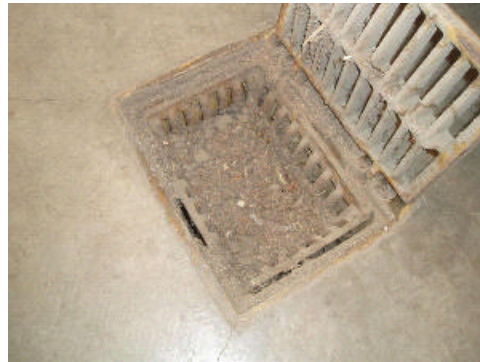
There are slab drains installed. They are full of debris. I recommend that they be cleaned.

2. There are slab drains installed. They are full of debris. I recommend that they be cleaned.

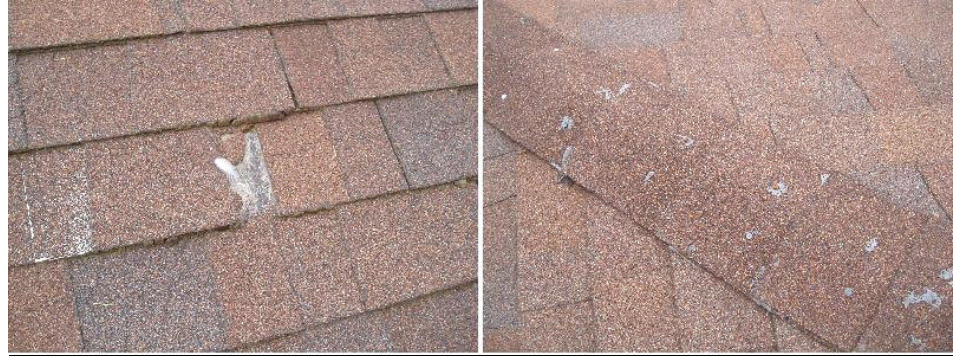
**Damaged shingle and popped nails**

The overall condition of the roof is fair with some aging noted in the form of minor cracking, a couple of popped nails, thinning granules, and fibers beginning to show on the edges of the ridge cap. I recommend minor repairs at this time. Moss is beginning to grow. I recommend a chemical treatment (such as moss out) to control the growth of moss.

4. The overall condition of the roof is fair with some aging noted in the form of minor cracking, a couple of popped nails, thinning granules, and fibers beginning to show on the edges of the ridge cap. I recommend minor repairs at this time. Moss is beginning to grow. I recommend a chemical treatment (such as moss out) to control the growth of moss.

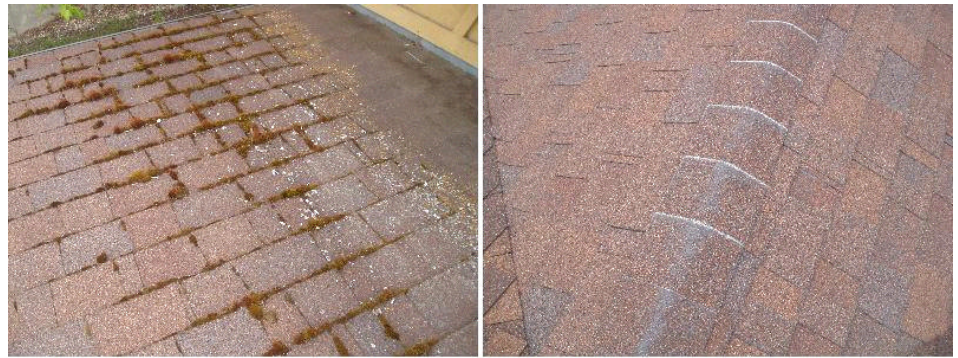
**Moss growth and fibers showing**

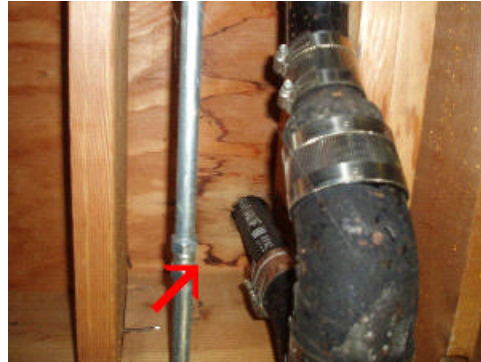
There are no signs of any current leaking in the waste lines at this time. Some water staining is noted in some areas of the plywood beneath the upstairs bathrooms. These stains are likely from a past leak.

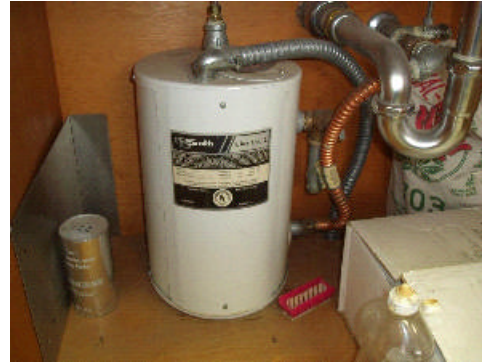
The unit is a point of use electric model manufactured in 1978.

APPROXIMATE AGE: 30 years - The average life expectancy of a water heater is 12 to 14 years. Depending on the quality of the component parts and the water quality it is not uncommon for them to last much longer. This one, although beyond the end of its statistical life appears to still be in good condition with no signs of leaking or rust. It should be monitored for leaking particularly around the base.

INSTALLATION: New construction required that the TPRV drain line be extended to terminate outside the home in a downward orientation no more than 6" from the ground. It should be of a qualified material such as copper, galvanized pipe or CPVC. I do not think that this requirement was in place at the time of the original installation. Consider extending this line to increase safety. It will need to be extended if the unit is replaced.

3. New construction required that the TPRV drain line be extended to terminate outside the structure in a downward orientation no more than 6" from the ground. It should be of a qualified material such as copper, galvanized pipe or CPVC. I do not think that this requirement was in place at the time of the original installation. Consider extending this line to increase safety. It will need to be extended if the unit is replaced.

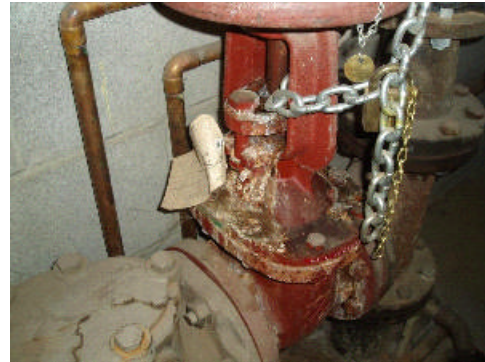
There is a small water leak at a large valve (fire sprinklers) that looks to have been leaking for some time with minor corrosion noted. This system is outside the scope of my inspection but I recommend it be further evaluated.

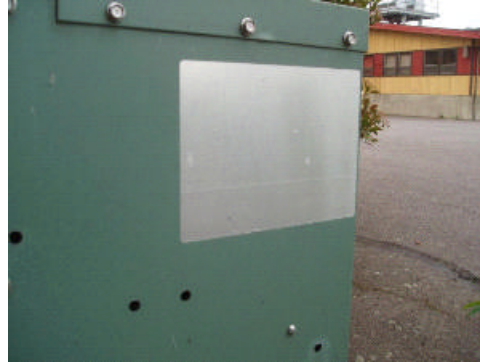
This is likely the original equipment from the late 1970s. The label is no longer legible due to oxidation. The size of the unit, the date of manufacturing, and the maximum amperage are not known.

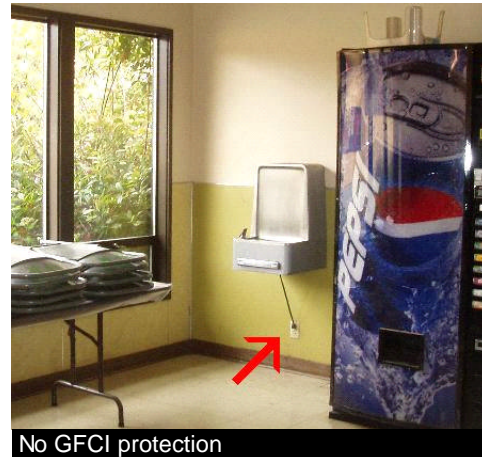
A representative number of outlets were tested and all appeared to be operating as intended. GFCI outlets were observed and tested in the upstairs bathrooms. GFCI protection was not observed at other outlet locations including at the exterior, the drinking fountain, etc. GFCI protection is recommended at all locations within 6 feet of water and at all exterior outlets. It is not a required upgrade but I recommend that these devices be installed at the recommended locations. There is a broken cover at an exterior outlet near the patio. I recommend a new one be installed.

1. A representative number of outlets were tested and all appeared to be operating as intended. GFCI outlets were observed and tested in the upstairs bathrooms. GFCI protection was not observed at other outlet locations including at the exterior, the drinking fountain, etc. GFCI protection is recommended at all locations within 6 feet of water and at all exterior outlets. It is not a required upgrade but I recommend that these devices be installed at the recommended locations. There is a broken cover at an exterior outlet near the patio. I recommend a new one be installed.

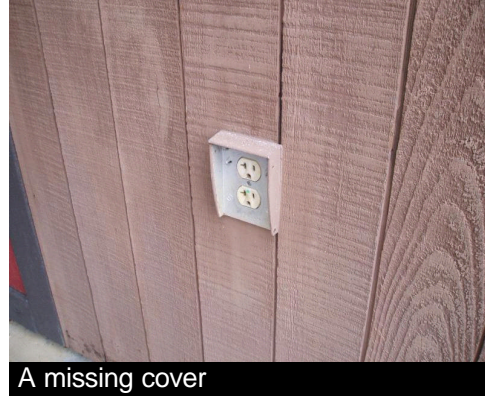
A missing cover

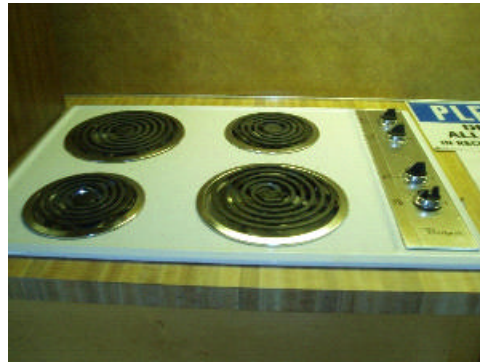
Electric - The burners and the elements were tested for operation and they all responded to the manual controls. The right front burner knob is broken making it difficult to control the burner. I recommend it be replaced.

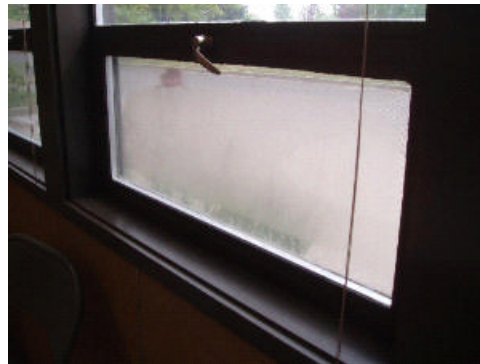
A random sample was tested and they were operating as intended. There is one (maybe two) window with a "blown seal" in the downstairs meeting area. Blown seals can be unsightly and reduce energy efficiency. I recommend they be replaced.

5. A random sample was tested and they were operating as intended. There is one (maybe two) window with a "blown seal" in the downstairs meeting area. Blown seals can be unsightly and reduce energy efficiency. I recommend they be replaced.

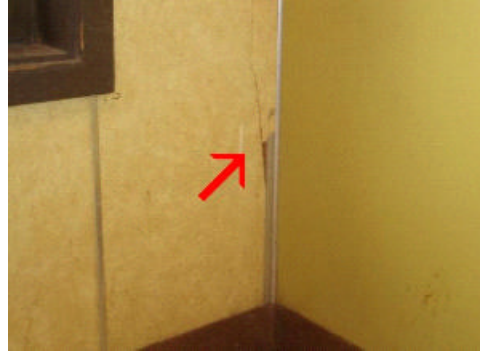
Drywall & Formica with some walls of concrete block downstairs. The overall condition is good with some minor damage to the formica at various locations including the upstairs foyer. The damage that is there is cosmetic in nature.

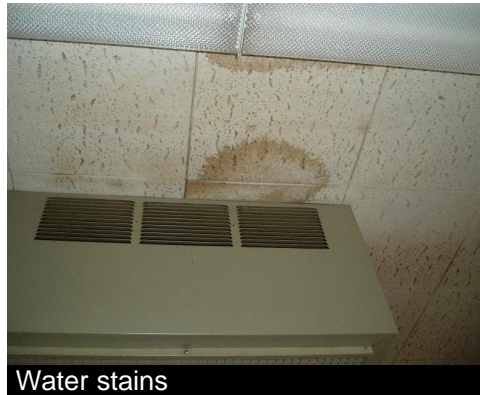
Water stains

The ceiling is made up of acoustic tiles. The overall condition is fair with some loose tiles and areas that have been patched. There is water staining in the downstairs meeting area near the ceiling mounted air filter. There was no moisture present at the time of the inspection and I was unable to tell where the water was coming from. I recommend that this area be monitored for signs of moisture.

4. The ceiling is made up of acoustic tiles. The overall condition is fair with some loose tiles and areas that have been patched. There is water staining in the downstairs meeting area near the ceiling mounted air filter. There was no moisture present at the time of the inspection and I was unable to tell where the water was coming from. I recommend that this area be monitored for signs of moisture.

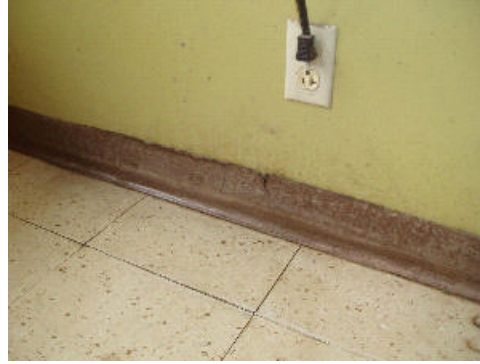
Door and window trim is good. The base cove at the floors is in fair to poor condition. Several broken section and sections pulling away from the wall were observed. Cosmetically the material is dried out and looks very worn. Repairs are possible but replacement is needed.

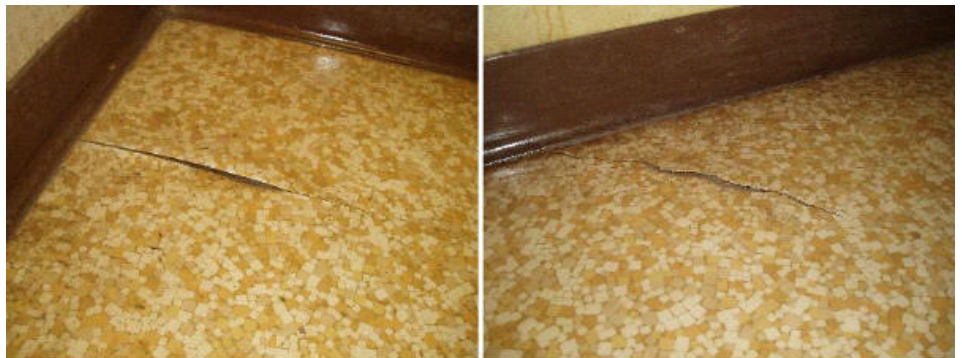
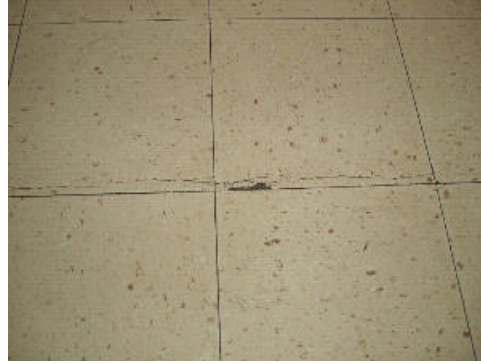
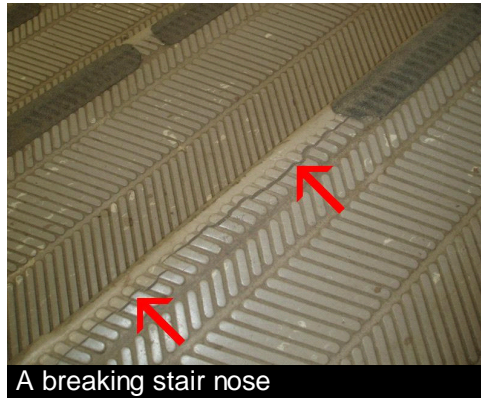
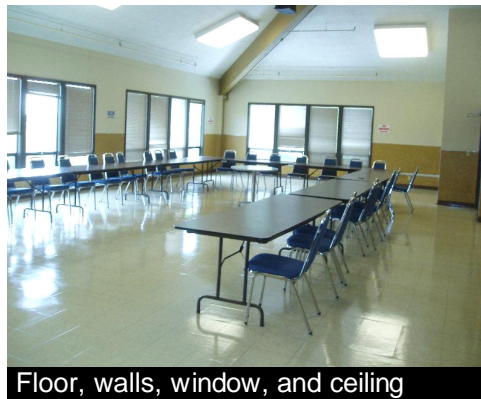
Vinyl - The vinyl flooring is in fair to poor condition with advanced aging noted in the form of softness where glue has failed, lifting seams, torn sections (upstairs women's bathroom), cracking, and overall poor appearance. One cracked section of vinyl on the stairway near a tread nose is a safety hazard. I recommend further evaluation for repairs or replacement by a licensed flooring contractor.

6. Vinyl - The vinyl flooring is in fair to poor condition with advanced aging noted in the form of softness where glue has failed, lifting seams, torn sections (upstairs women's bathroom), cracking, and overall poor appearance. One cracked section of vinyl on the stairway near a tread nose is a safety hazard. I recommend further evaluation for repairs or replacement by a licensed flooring contractor.

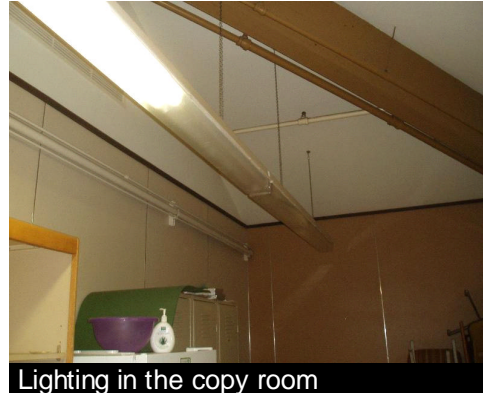
Lighting in the copy room

Some of the light fixtures are not functioning and are presumed to have burned out bulbs. This is true in the upstairs copy room where only 2 of 8 lights are functional and in the drying room downstairs. I recommend all of the lights be functional.

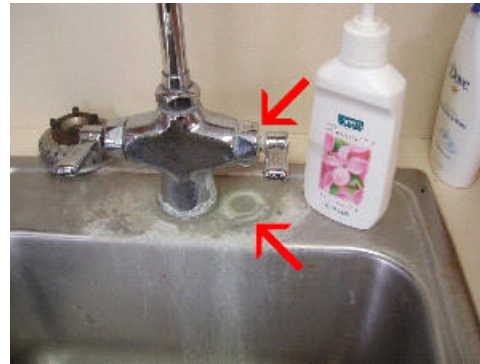
There is a stainless steel sink located in the small office at the right front corner of the building. The cold water faucet is leaking. I recommend it be repaired.

7. There is a stainless steel sink located in the small office at the right front corner of the building. The cold water faucet is leaking. I recommend it be repaired.

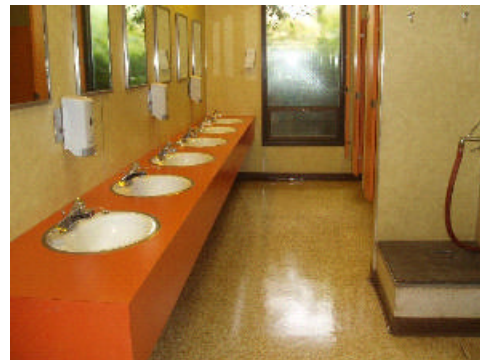
There are six sinks and faucets in this bathroom. Generally they are in good condition. However, the second and sixth sink have leaks in the drain lines. I recommend that these leaks be eliminated.

8. There are six sinks and faucets in this bathroom. Generally they are in good condition. However, the second and sixth sink have leaks in the drain lines. I recommend that these leaks be eliminated.

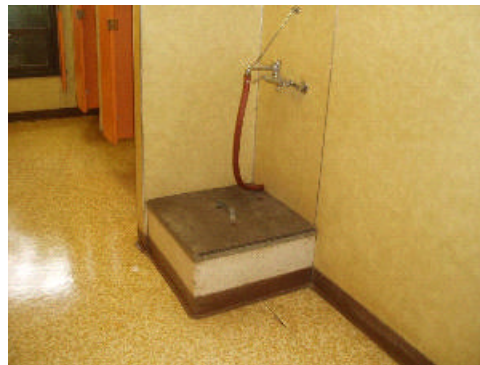
There is a mop sink installed. The faucets are leaking when the faucets are on. I recommend new seals be installed. This is true of the mop sink in the men's restroom also.

9. There is a mop sink installed. The faucets are leaking when the faucets are on. I recommend new seals be installed. This is true of the mop sink in the men's restroom also.

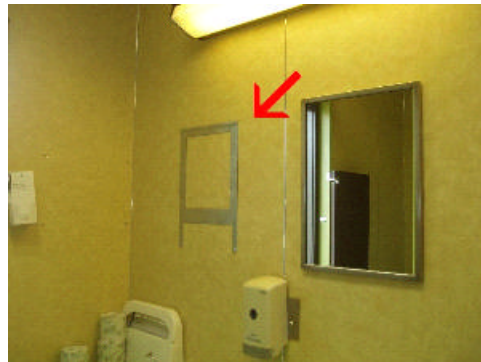
One of the mirrors is missing in this bathroom. I recommend a new mirror be installed.

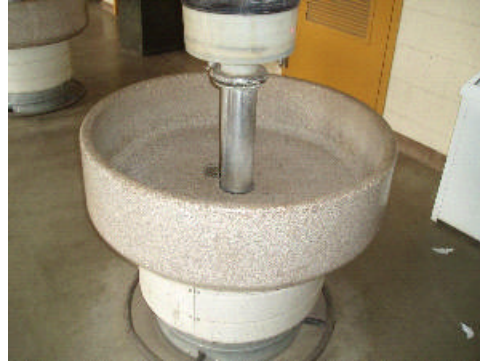
The sinks are located in the main area. They are a circular foot operated type. One of the valves is leaking. I recommend it be repaired.

10. The sinks are located in the main area. They are a circular foot operated type. One of the valves is leaking. I recommend it be repaired.

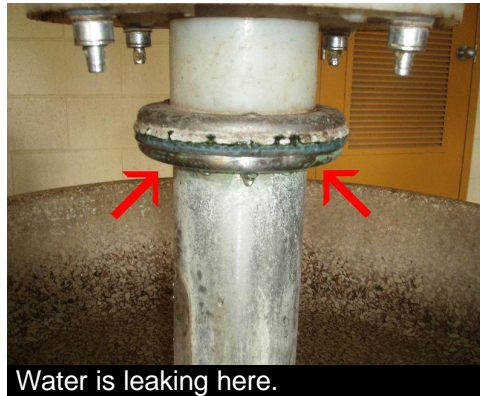
Water is leaking here.

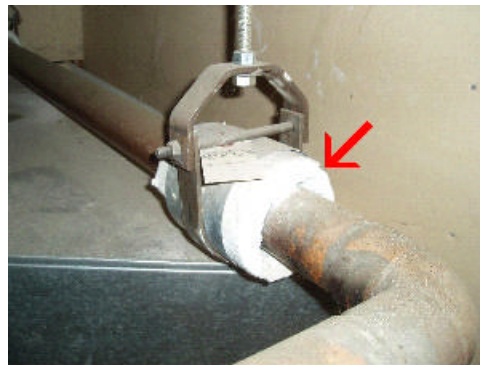
Pipe insulators located in the attic off the copy room may contain asbestos. Samples were taken from a company whose tag reads BWR is located near the material. It is likely that the results of this sampling and of many others taken throughout the complex are available from this company. Other possible asbestos containing product found are: acoustic ceiling tiles, HVAC duct cement and tape.
