Inspection Report

Prepared by: Cornerstone Inspections
4678 Glen Echo Way
Central Point, OR 97502
541-664-1947

September 15, 2008
Prepared for:
Your name here
Property Inspected:
123 Any St
Medford, OR 97504
Client's Realtor:
Your Realto

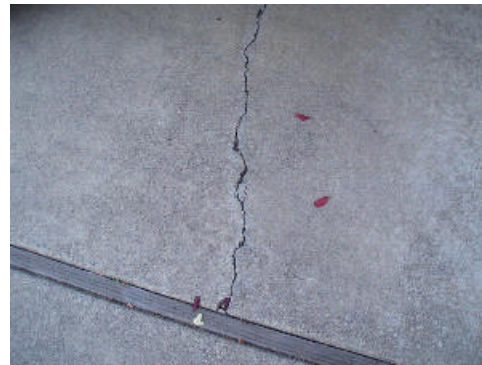
CONDITION:

In fair condition - Cracking is noted. Sealing the cracks to keep moisture out will slow down deterioration.

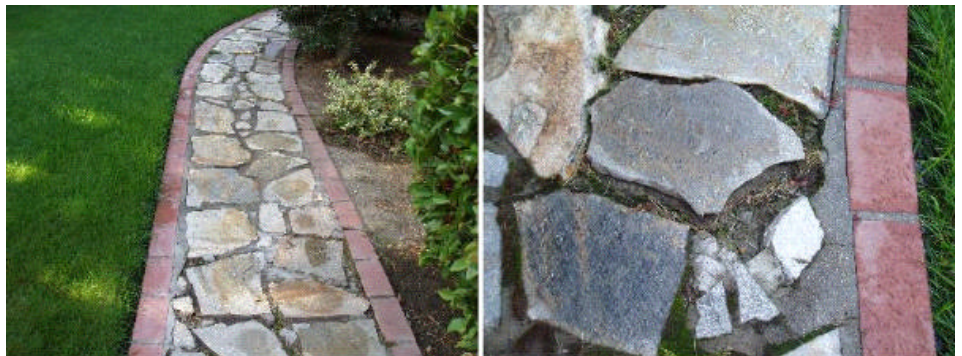
Stone walkways are present at the rear. Loose stones and broken mortar are noted. I recommend that this condition be corrected.

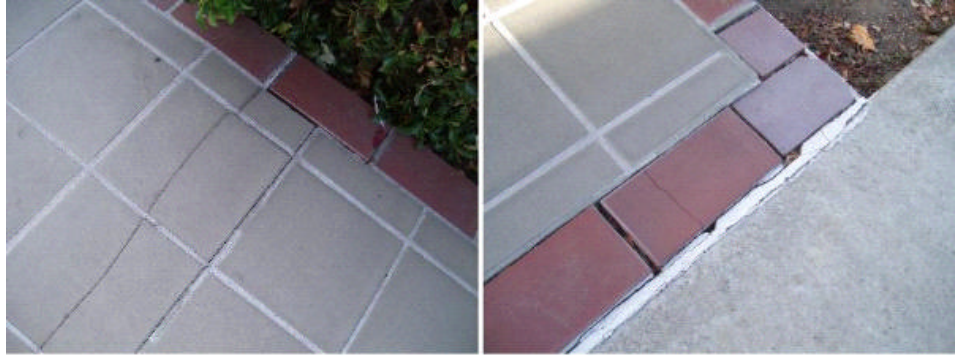
There is a tile and brick walkway in the front. In fair condition with some cracked tiles and brick. There is also some deteriorated and missing mortar noted.

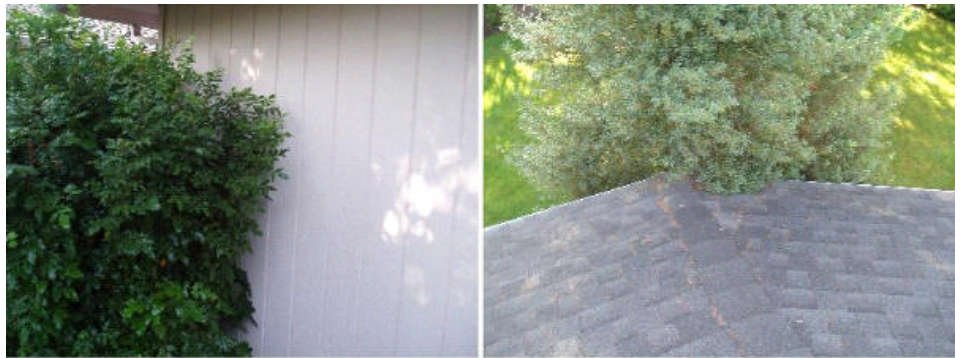
I recommend that the foliage be trimmed away from the structure. Plants and trees that are against the structure can wear away materials such as asphalt roof granules and paint. They also tend to slow the evaporation of moisture which can accelerate the breakdown of many materials.

1. I recommend that the foliage be trimmed away from the structure. Plants and trees that are against the structure can wear away materials such as asphalt roof granules and paint. They also tend to slow the evaporation of moisture which can accelerate the breakdown of many materials.

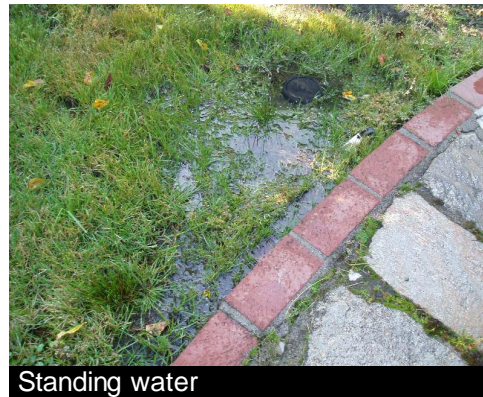
Standing water

Flat site sloping away toward the street. - There is no evidence of adverse conditions caused by standing water or erosion. There was some standing water to 1.5 inches at the rear of the home when I began the inspection. At the end of the inspection there was considerably less but the area was still swampy. I could not locate the source of the water. It may have been from the sprinklers or it may be that there is a leak. I recommend that the source of the water be located and eliminated. If it is from the sprinklers I recommend that the volume of water be reduced.

2. Flat site sloping away toward the street. - There is no evidence of adverse conditions caused by standing water or erosion. There was some standing water to 1.5 inches at the rear of the home when I began the inspection. At the end of the inspection there was considerably less but the area was still swampy. I could not locate the source of the water. It may have been from the sprinklers or it may be that there is a leak. I recommend that the source of the water be located and eliminated. If it is from the sprinklers I recommend that the volume of water be reduced.

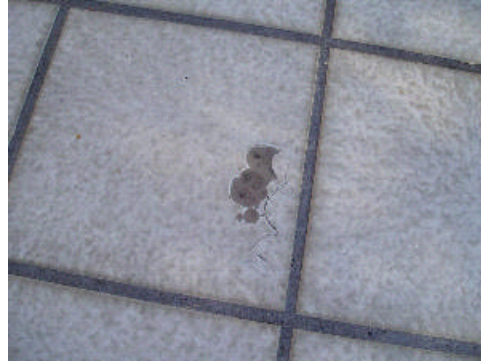
There is a tile patio in the rear. The overall condition is fair with some chipped and cracked tiles noted.

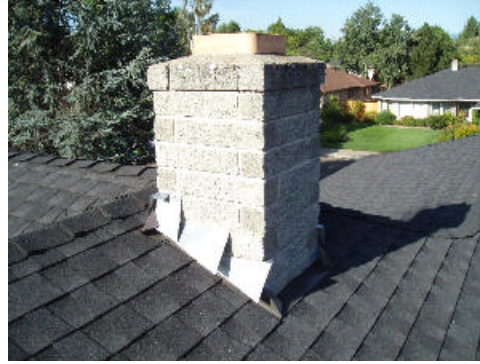
The chimney appears to be in good condition with no visible cracks in the brick, mortar, or chimney cap. The inside of the chimneys are not inspected. Consider installing a spark arrestor to help keep sparks contained and to prevent water from entering the chimney and rusting the damper mechanism.

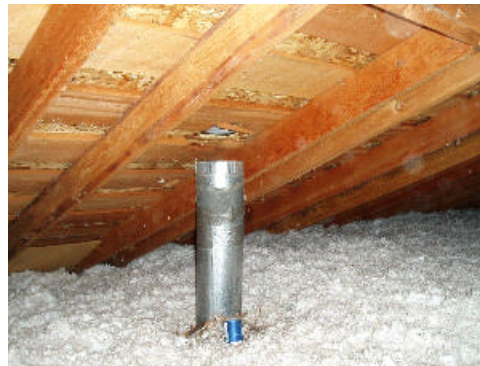
THROUGH ATTIC VENTING:

The range hood vent terminates in the attic. This condition allows a range fire to quickly spread through the attic. I recommend the range hood vent terminate at the exterior of

the home. There is a roof vent directly above the current termination point. The duct can be extended to this roof vent.

1. The range hood vent terminates in the attic. This condition allows a range fire to quickly spread through the attic. I recommend the range hood vent terminate at the exterior of the home. There is a roof vent directly above the current termination point. The duct can be extended to this roof vent.

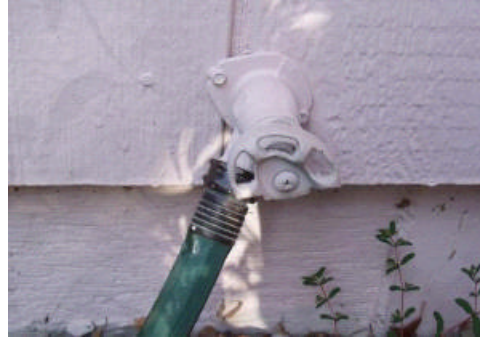
All of the hose faucets were tested and functioned as intended. There is a broken handle at the rear faucet. I recommend replacement as needed.

2. All of the hose faucets were tested and functioned as intended. There is a broken handle at the rear faucet. I recommend replacement as needed.

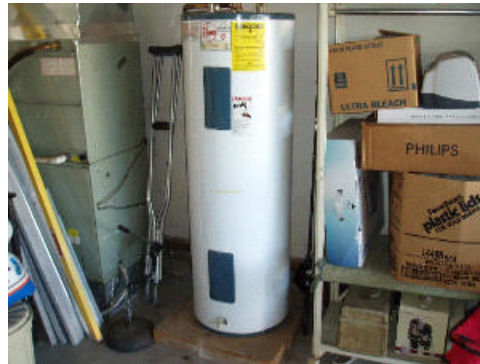
The unit is an electric model manufactured in 1996.

12 years - The average life expectancy of a water heater is 12 to 14 years. Depending on the quality of the component parts and the water quality it is not uncommon for them to last much longer. This one, although at the end of its statistical life appears to still be in good condition with no signs of leaking or rust. It should be monitored for leaking particularly around the base.

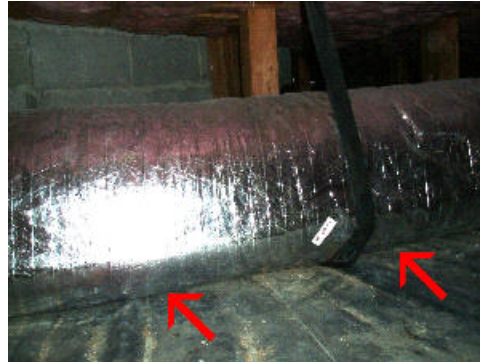
All of the registers were receiving conditioned air. One duct in the crawl space is on the ground. Its straps have come loose. I recommend that new straps be installed to keep it elevated.

4. All of the registers were receiving conditioned air. One duct in the crawl space is on the ground. Its straps have come loose. I recommend that new straps be installed to keep it elevated.

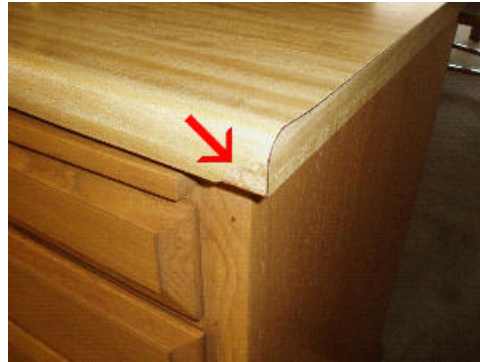
COUNTERS CONDITION:

Formica (plastic laminate) - In fair condition with some wear and one damaged corner. This condition is cosmetic in nature and should be evaluated by the buyer.

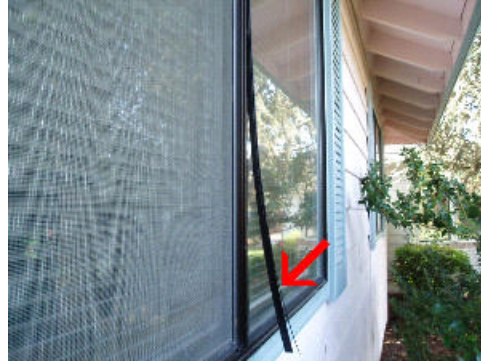
A random sample was tested and they were operating as intended. One of the plastic trim pieces at the front of the home is damaged. I recommend repairs or replacement as needed.

6. A random sample was tested and they were operating as intended. One of the plastic trim pieces at the front of the home is damaged. I recommend repairs or replacement as needed.

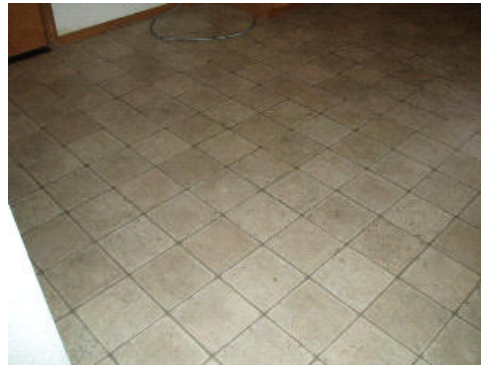
Vinyl - The general condition is fair with wear noted in the kitchen.

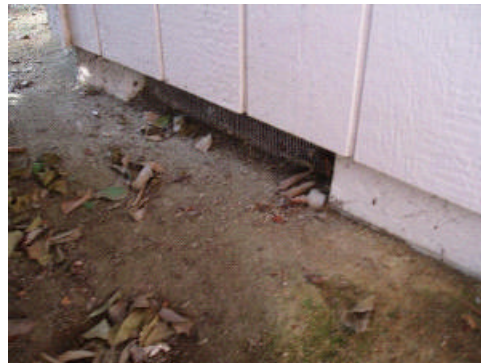
CRAWL SPACE VENTILATION:

The understructure is adequately ventilated. Two of the vents at the rear of the home are at or below grade. This can be an entry point for water during heavy rains. I recommend installing vent wells to help keep water from entering the crawl space.

7. The understructure is adequately ventilated. Two of the vents at the rear of the home are at or below grade. This can be an entry point for water during heavy rains. I recommend installing vent wells to help keep water from entering the crawl space.

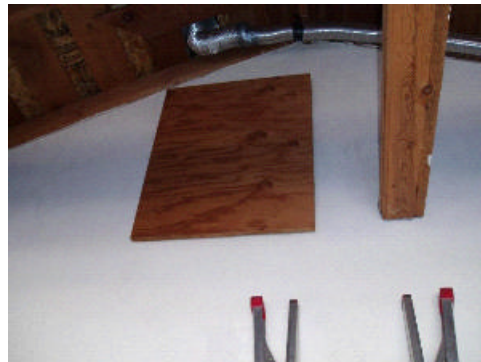
FIRE WALL

The wood attic access door compromises the integrity of the fire wall and should be replaced or lined with metal or sheetrock.

3. The wood attic access door compromises the integrity of the fire wall and should be replaced or lined with metal or sheetrock.
