## Inspection Report

**Prepared by: Cornerstone Inspections**  
4678 Glen Echo Way  
Central Point, OR 97502  
541-664-1947

## INSPECTION REPORT

TYPE OF BUILDING:	A commercial building, two stories high, site built using stick framing.
-------------------	--

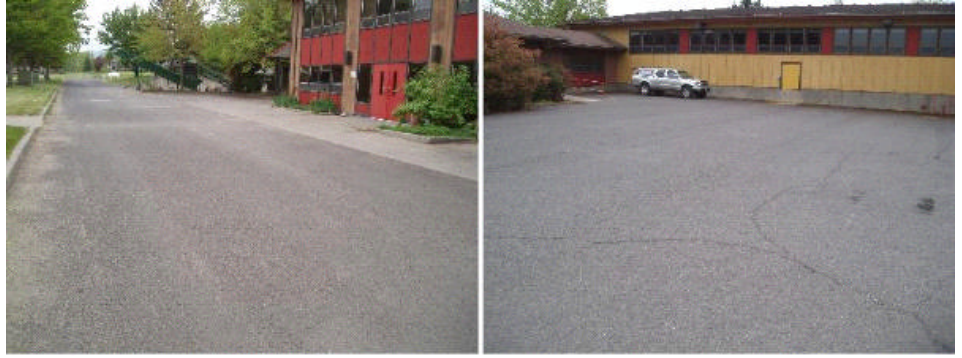
Asphalt

In good condition. Cracks are noted. Sealing the cracks to keep moisture out will slow down deterioration.

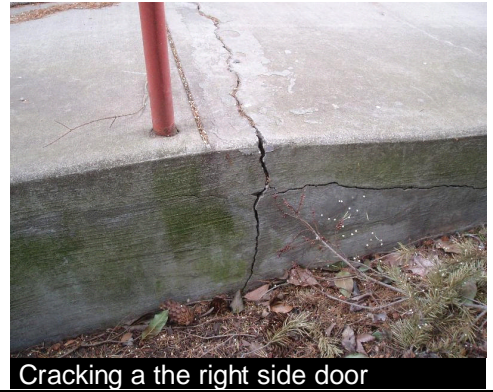
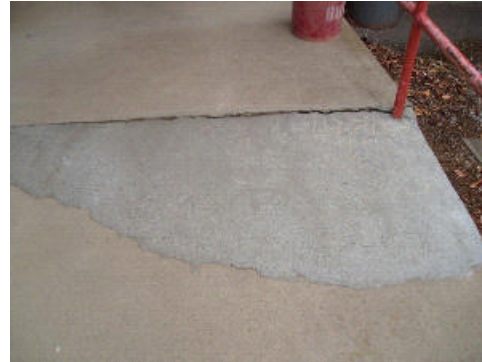
A patched section near the rear entrance

Concrete - In fair condition with patching noted. There are currently no tripping hazards or serious deterioration. There is a crack in the walkway to the right side door.

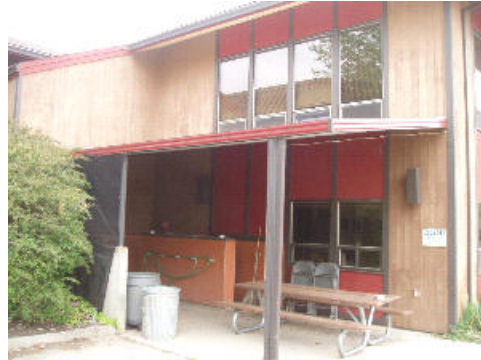
There is a patio like area at the left front corner of the building that is a break area and also has some equipment for washing.

In good condition.

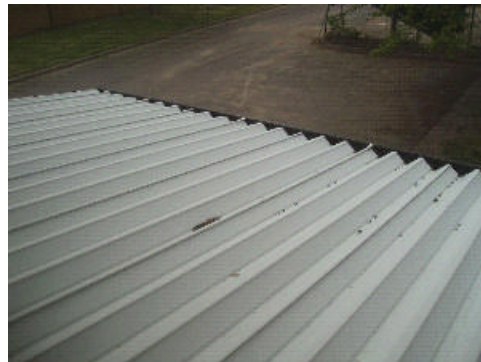
The cover is metal roofing material over metal framing.

Properly installed and in good condition.

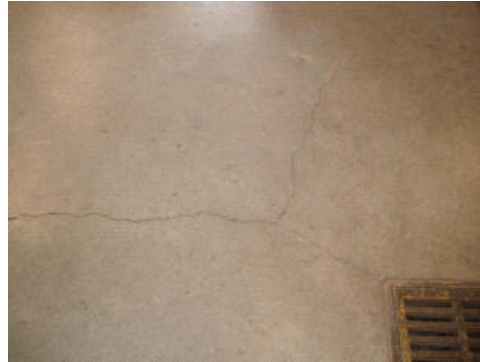
Good with some cracking noted but no displacement.

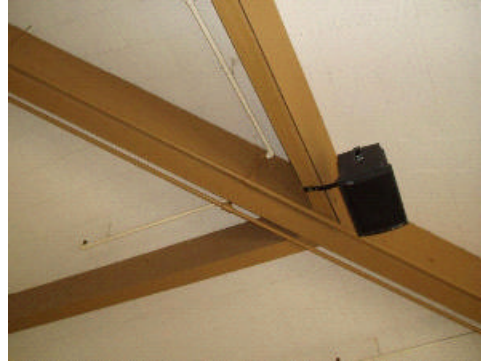
The main framing members are large "glu-lams". The rafters are conventional framing using 2X6 lumber. No adverse conditions were noted.

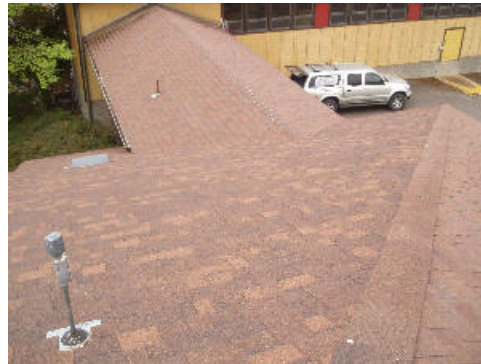
Composition shingles

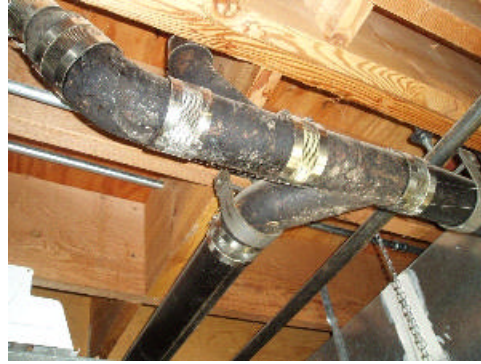
Cast Iron

There are no signs of any current leaking in the waste lines at this time. Some water staining is noted in some areas of the plywood beneath the upstairs bathrooms. These stains are likely from a past leak.

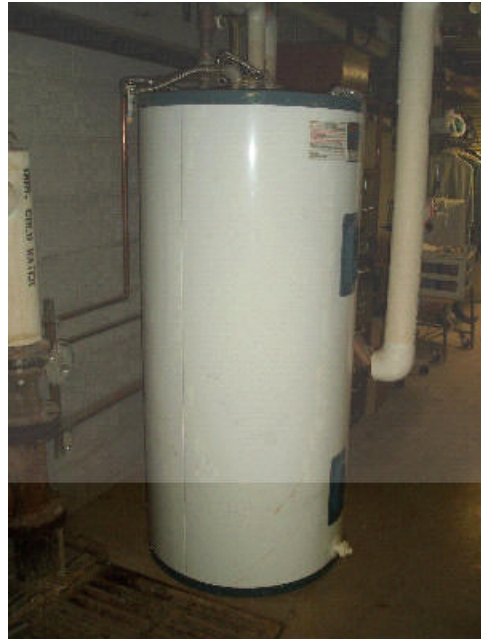
The unit is an electric model manufactured in 2000.

APPROXIMATE AGE: 30 years - The average life expectancy of a water heater is 12 to 14 years. Depending on the quality of the component parts and the water quality it is not uncommon for them to last much longer. This one, although beyond the end of its statistical life appears to still be in good condition with no signs of leaking or rust. It should be monitored for leaking particularly around the base.

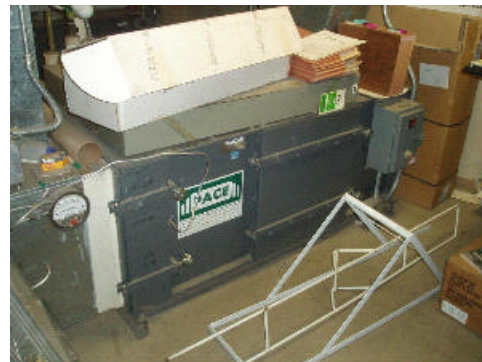
The heating system is a heat pump type of unit with three air handlers and three blast coils.

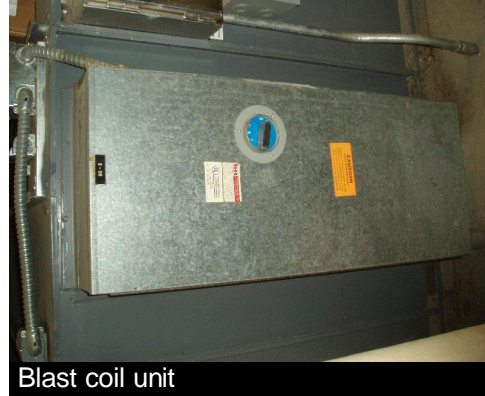
Blast coil unit

Pace for the air handlers and Warren for the blast coils.

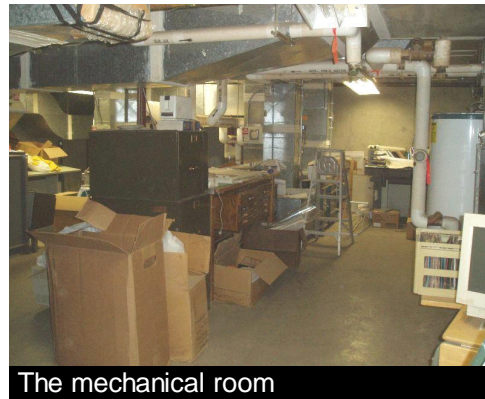
The mechanical room

There is a small water leak at a large valve (fire sprinklers) that looks to have been leaking for some time with minor corrosion noted. This system is outside the scope of my inspection but I recommend it be further evaluated.

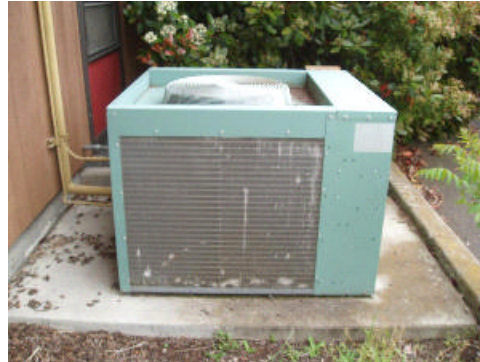
Good - The unit looks to be in good condition.

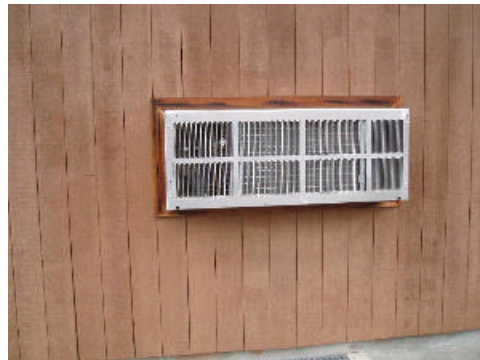
There is a wall mounted air conditioner in the copy room. It was tested for installations and power only. The unit was properly installed and responded appropriately to the onboard controls.

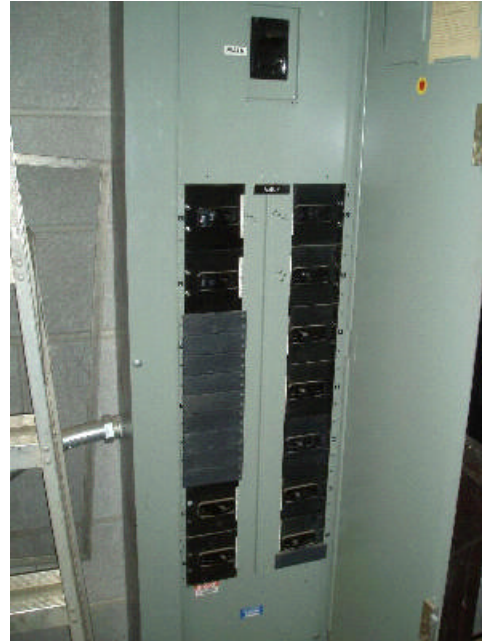
In the mechanical room

The panel is in good condition with the right sized wiring for the breakers and no adverse conditions noted.

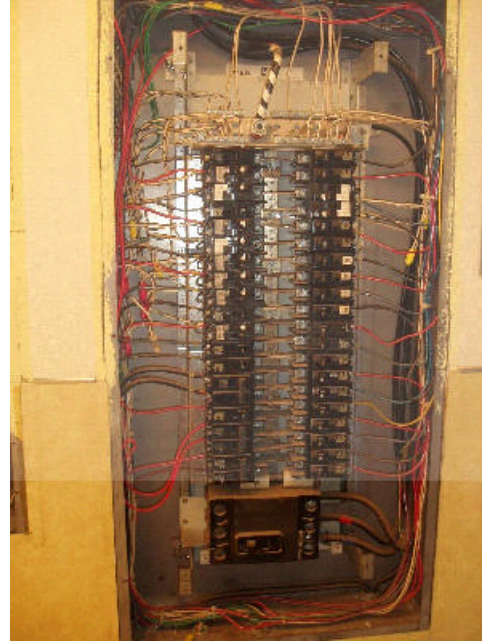
In the upstairs hallway

The panel is in good condition with the right sized wiring for the breakers and no adverse conditions noted.

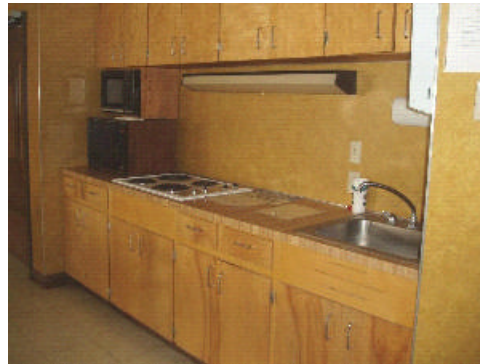
There is a small kitchen in the upstairs meeting hall. It has a stainless steel sink. The sink is in good condition with no dents or scratches.

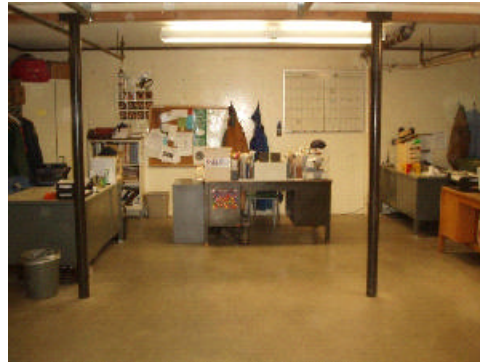
Water stains

The ceiling is made up of acoustic tiles. The overall condition is fair with some loose tiles and areas that have been patched. There is water staining in the downstairs meeting area near the ceiling mounted air filter. There was no moisture present at the time of the inspection and I was unable to tell where the water was coming from. I recommend that this area be monitored for signs of moisture.

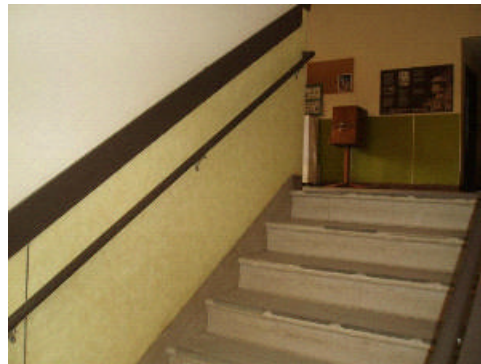
Interior stairs are in good condition. The railings are secure. As noted in the flooring

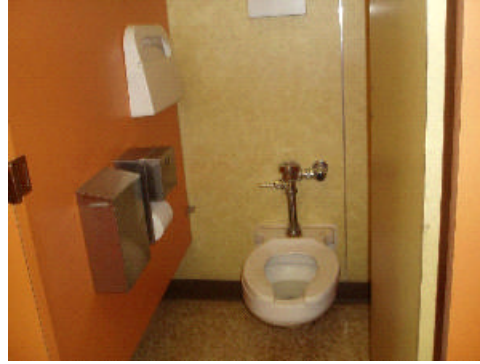
There are three - Firmly mounted to the wall and in good condition.

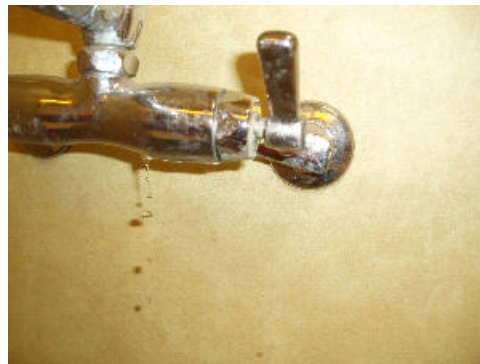
There is a mop sink installed. The faucets are leaking when the faucets are on. I recommend new seals be installed. This is true of the mop sink in the men's restroom also.

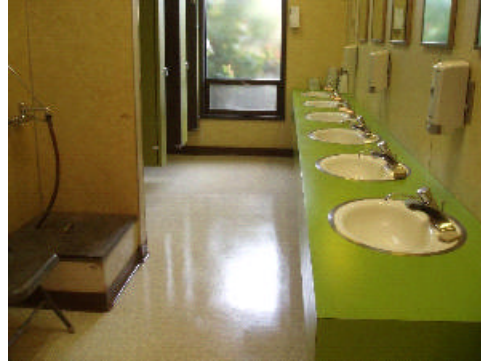
Off the hallway

CONDITION OF SINK/FAUCETS:	There are six faucets that are all in good working order.
CONDITION OF TOILET:	There are two toilets and one urinal. They are all functioning as intended.
WALLS/FLOORS/CEILING:	The vinyl is worn with lifting at the seams.
WINDOW:	Good
OTHER OBSERVATIONS:

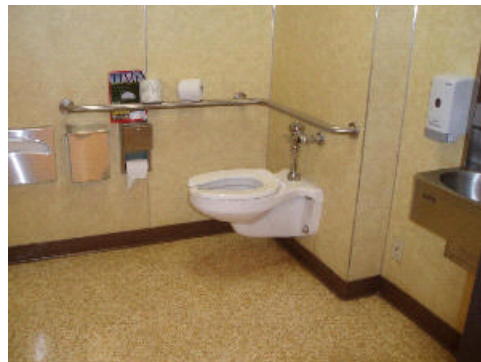
Off the hallway

CONDITION OF SINK/FAUCETS:	Good - The faucet and drain line show no signs of leaking and the stopper is functioning.
CONDITION OF TOILET:	The toilet is functioning as intended. It is mounted firmly to the floor.
WALLS/FLOORS/CEILING:	Good

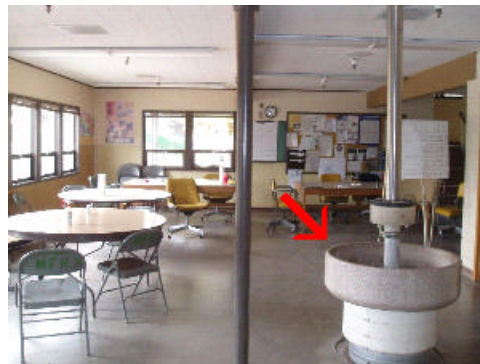
Again, the sinks are located outside the restrooms.

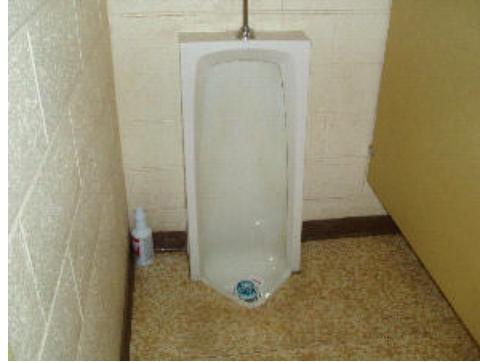
There are two toilets and one urinal. They are properly installed and fully functional.
